Montgomery County Trash TMDL Monitoring Update Summary

Montgomery County Trash TMDL Monitoring Update Summary Fall Sampling Period (October 2011)

Montgomery County Trash TMDL Monitoring Update Summary Summer Sampling Period (July 2012)

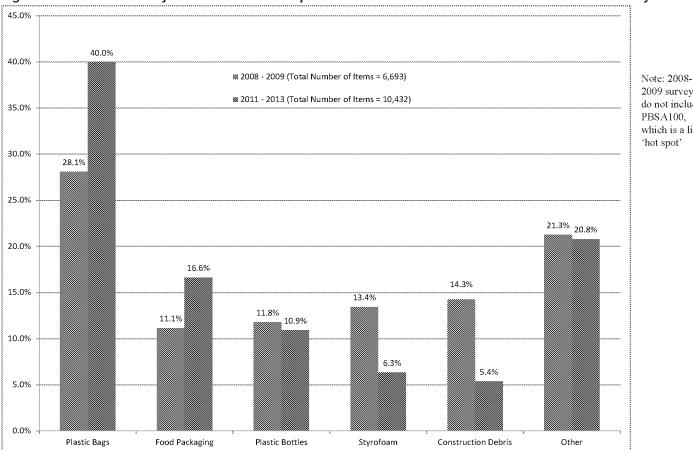
Figure 5. Stream Summary - Percent Total of Top Five Trash Items for 2008- 2009 and 2011-2013 Surveys

- Figure 5 shows the percent of total items for the top five trash categories for the 2008-2009 and 2011-2013 survey periods. Plastic bags, food packaging, plastic bottles, Styrofoam and construction debris remain the top trash items observed in the 2011-2013 period. Interestingly, the proportions

- of counts of plastic bags and food packaging increased from the 2008-2009 surveys to the 2011-2013 surveys.
- Figure 6 shows the total count for the top five trash categories for 2008/2009 through 2013. There is a general decreasing trend for plastic bag, plastic bottle and Styrofoam trash categories. (It should be noted that the LPLP205 and PBSA100 data were not included since these sites were not surveyed during both the 2008-2009 and 2011-2013 periods.)

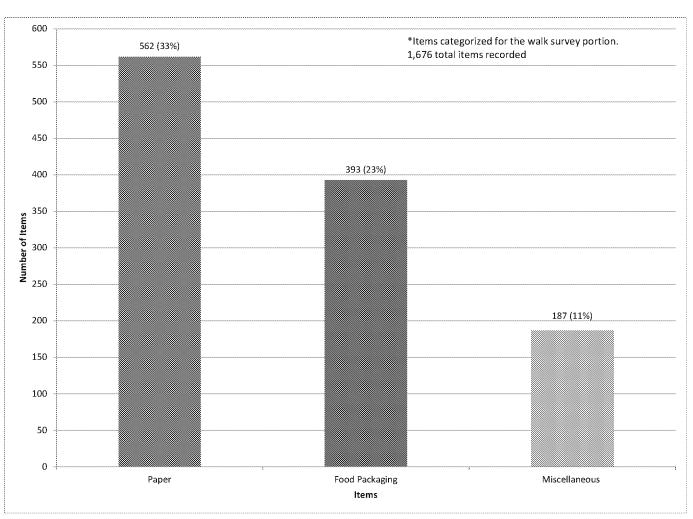
Figure 9. Summary - 300 Foot Walk Survey Top-Three Trash Items* (February 2012 to January 2013)

- For the walk survey portion, there were 1,676 total items counted. Of that total, the top three trash items were Paper, Food Packaging and Miscellaneous (Figure 9).

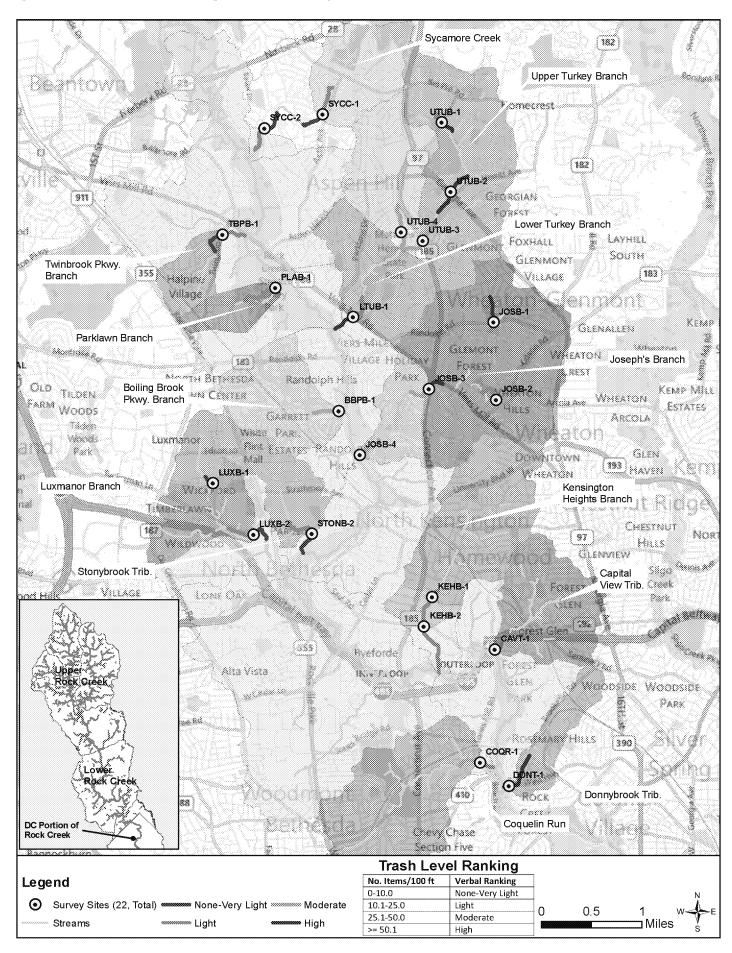
Figure 11. Rock Creek Bandalong and Trash Survey Locations

COG completed 22 candidate site evaluations including 10.3 miles (total) of associated stream trash surveying. For each of the 22 sites (Figure 11), site condition concept sketches and photographic documentation were generated.
